INVESTIGATIONAL REPORT

AN INVENTORY OF SANDMINING OPERATIONS IN KWAZULU-NATAL ESTUARIES: Thukela To Mtamvuna

SEPTEMBER 2007

Nicolette Demetriades
Marine & Estuarine Research

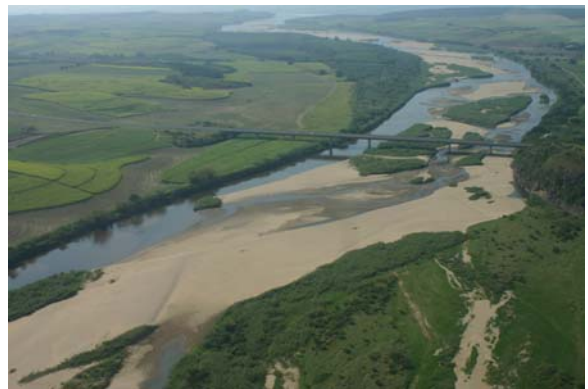
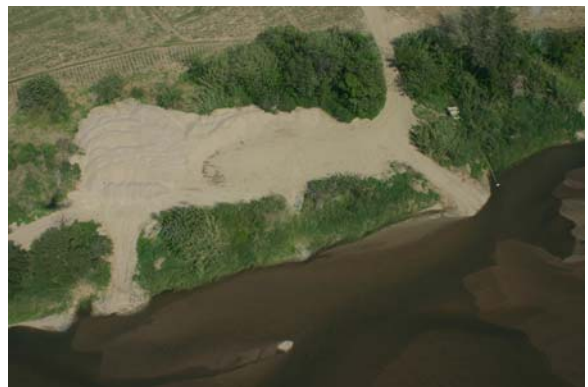
4.1 *Thukela*

- Only one very small localised operation on the north bank of the river west of the N2 bridge.
- Although small, the operation has cleared important stabilising riparian vegetation and created a potential erosion point
- This river and estuary is a likely target for future sand mining applications as there are many large sandbanks present
- Presently appears that access is prevented due to land ownership
- This river is an important source of sand for the prograding (depositional) coastline north of the Thukela (Forbes & Demetriades 2000) and this function may be threatened by two proposed new large dams. Sandwinning would exacerbate this
- The source of sand for the proposed north Thukela estates need to be carefully considered

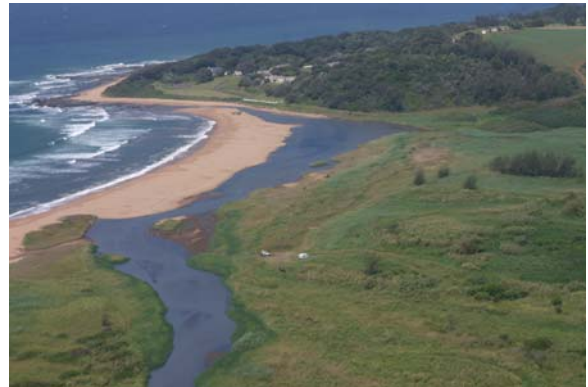
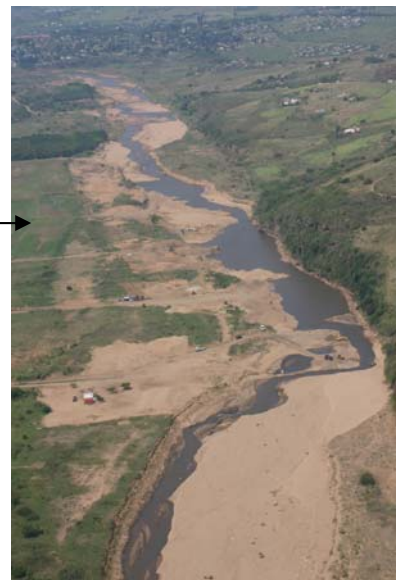
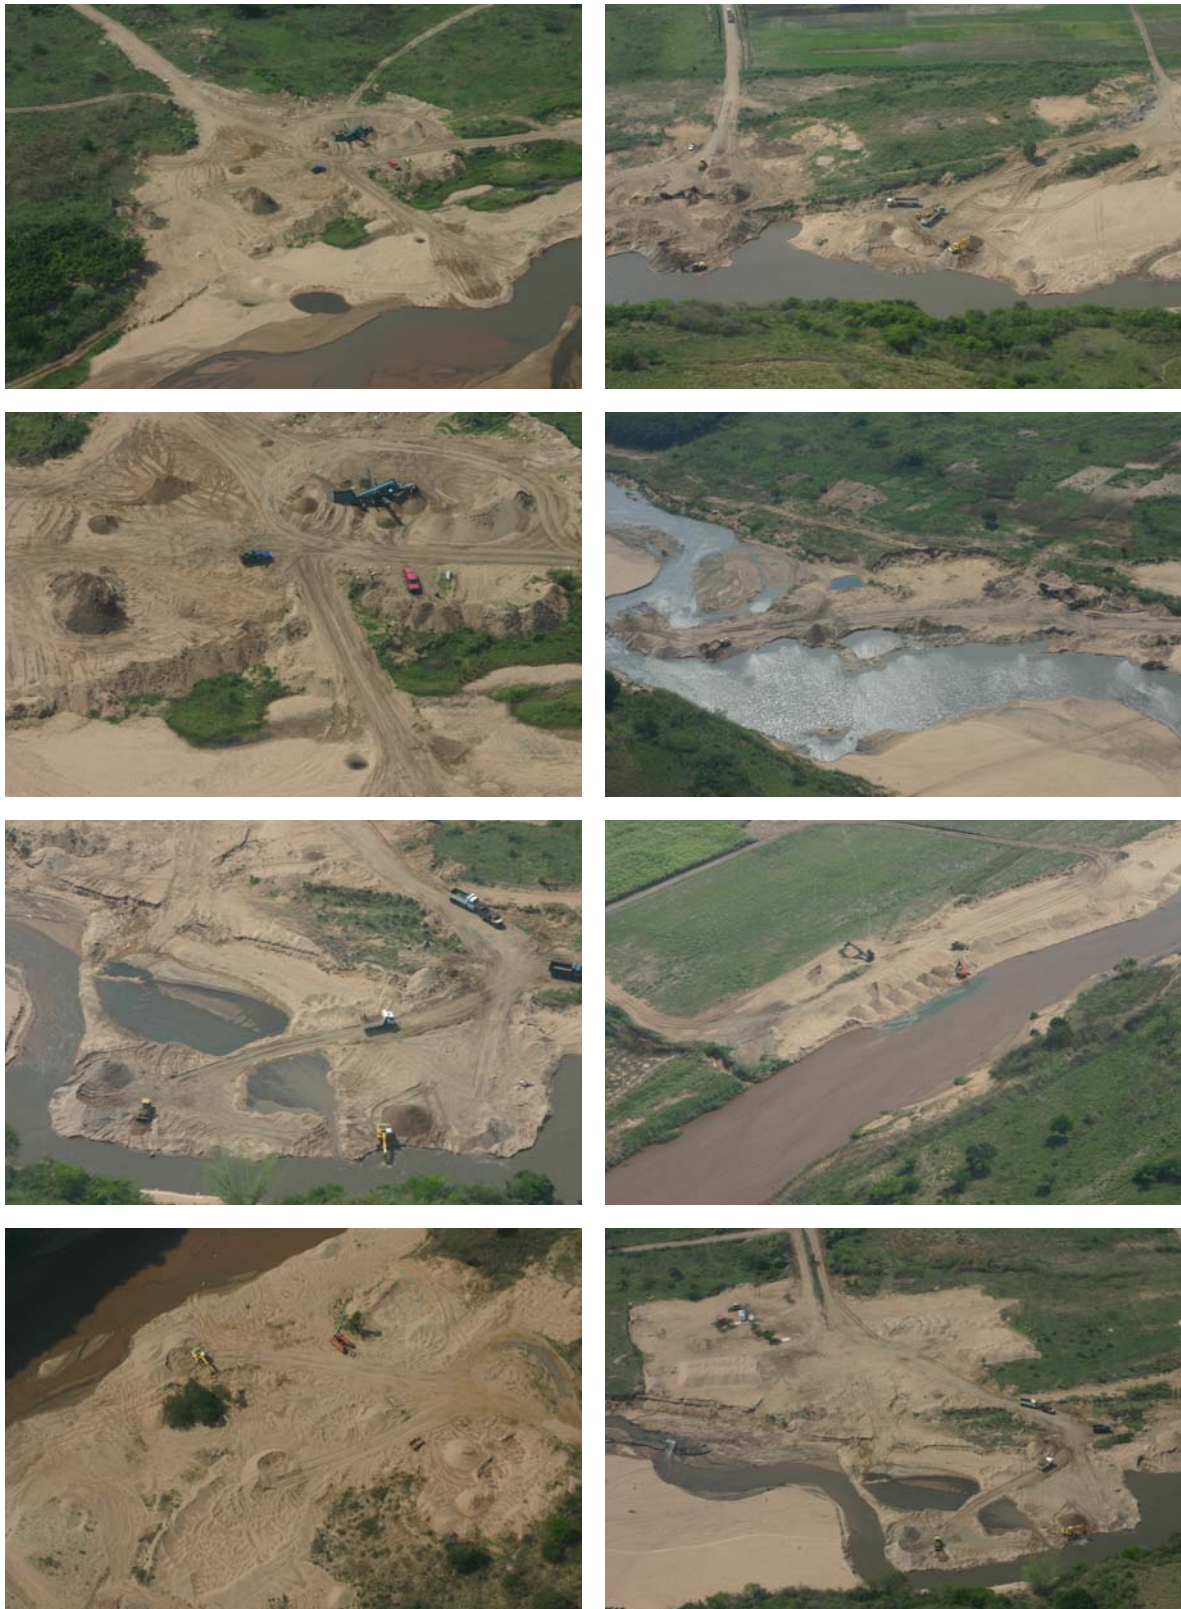
Plate 1: Individual sand mining operations on the Mvoti River. Many show clearly the irresponsible operating practices – riparian zone clearing, diversion of flow, stockpiling on edge of river, multiple access points across floodplain and creation of large erosion areas

- While the GPS co-ordinates listed above suggest 5 distinct operations it is likely that there are 8 – 10 operators. These were, however, almost impossible to separate as the operations run continuously with no recognisable boundaries between them. —————→

- Each of the operations has a separate access road to the river stretch thus increasing negative impacts associated with heavy vehicles and machinery on the floodplain

- Mobilisation of large areas of unconsolidated sediments are very likely resulting in sedimentation of the estuary and changes to the sediment composition. This translates into a direct loss of estuarine habitat and productivity.

- Disruption of benthic communities within estuary and at the riverine estuarine interface
- Removal of riparian habitat and decrease in floodplain function will adversely affect the estuarine system

- Changes in downstream turbidities (water clarity) which strongly influence estuarine biotic communities particularly fish.
- There is a strong risk of erosion due to large number of sand mining operations in close proximity

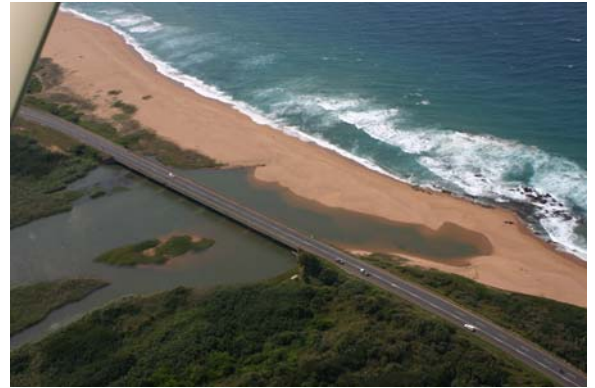
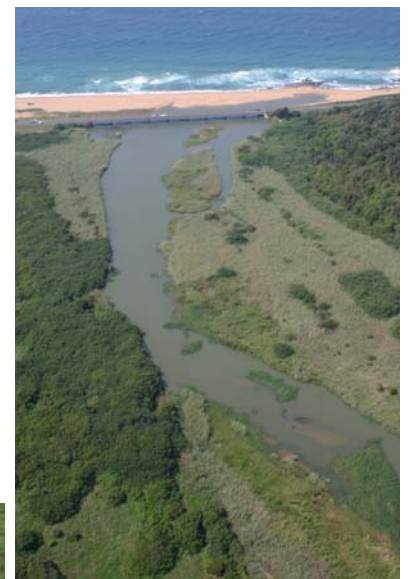
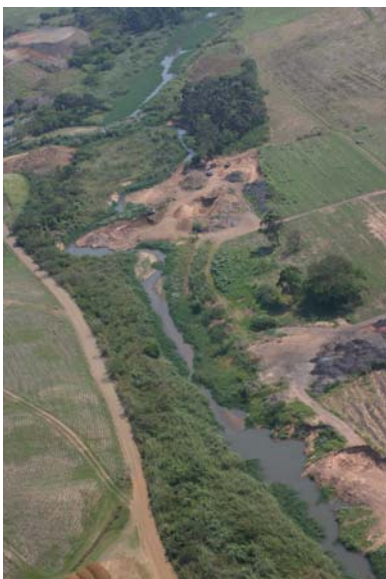
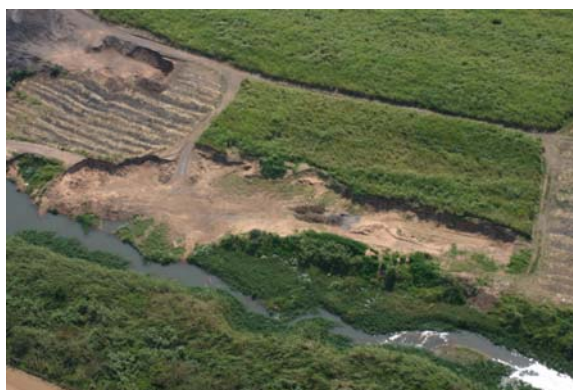
4.4 *Tongati*

- Only two relatively small operations, west of the N2 highway, were observed on the river reach of the Tongati estuary
- While these are small relative to the operations on systems further north the Tongati is a smaller estuary and the relative impacts of the operations are likely similar.
- Operations were again characterised by haphazard removal of riparian vegetation and river diversion.
- The Tongati estuary has shallowed significantly over the past 20 years and operations which increase erosion and movement of sediment into the river will ultimately result in the further sedimentation of the estuary.

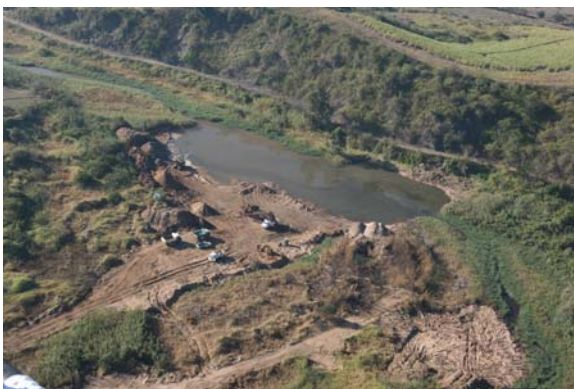
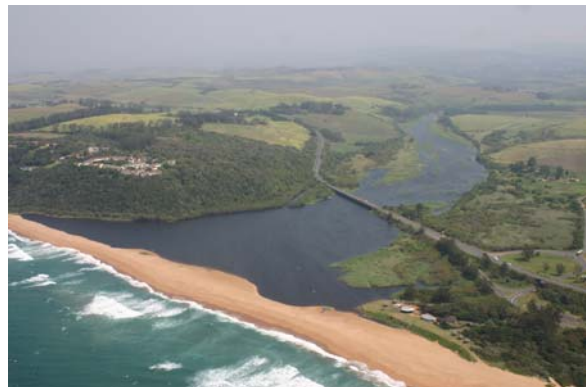
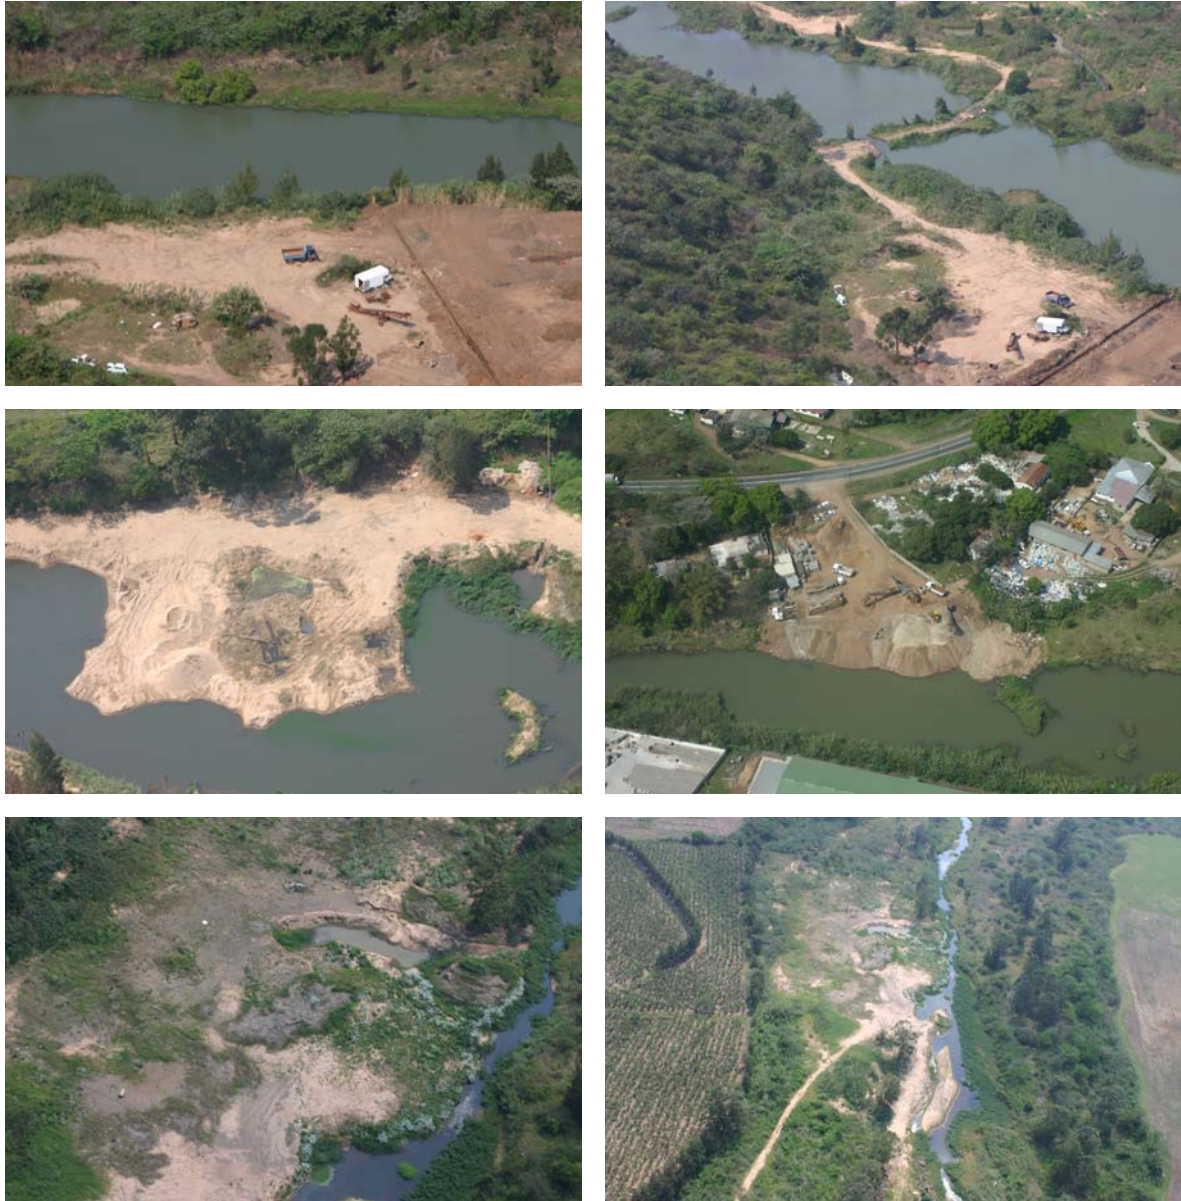
Plate 3: *Past and present sand mining operations on the Mdloti estuary. Note that there is no evidence of rehabilitation of old sites. Infilling of the river channel in Verulam (right centre) is of particular concern*

- Three relatively small operations were observed on the Mdloti river, both located west of the N2 highway
- Operations were again characterised by destruction of riparian vegetation along the river banks with little evidence of rehabilitation of the past operations.
- Construction of sand berms across the river to facilitate movement of trucks results in diversion and constriction of flow and the sediment used in berm construction becomes yet another source of sediment to the estuary during high flows.

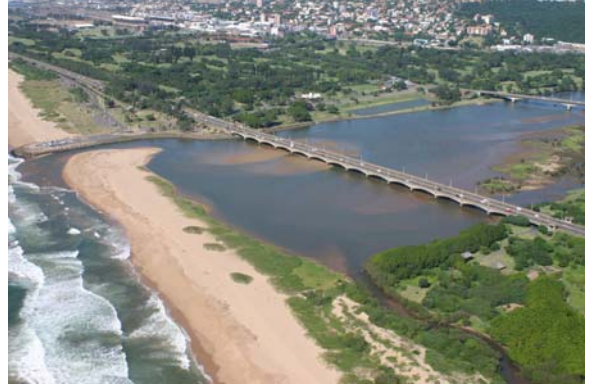
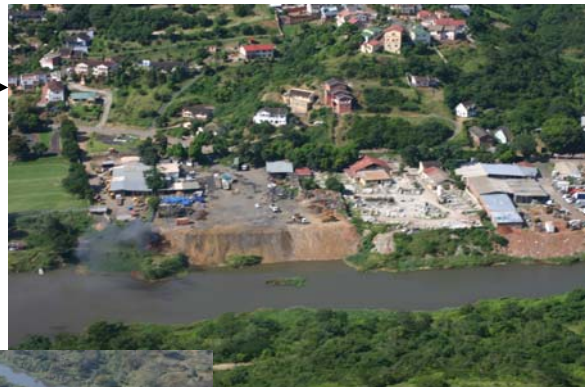
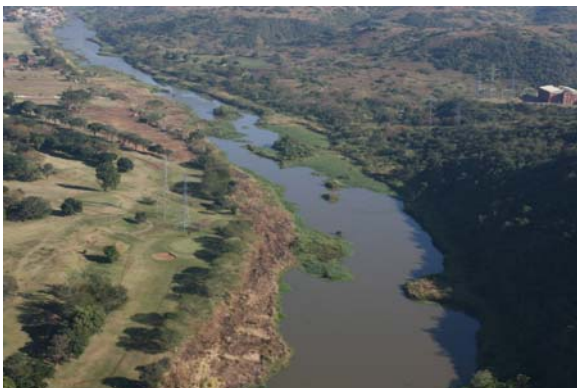
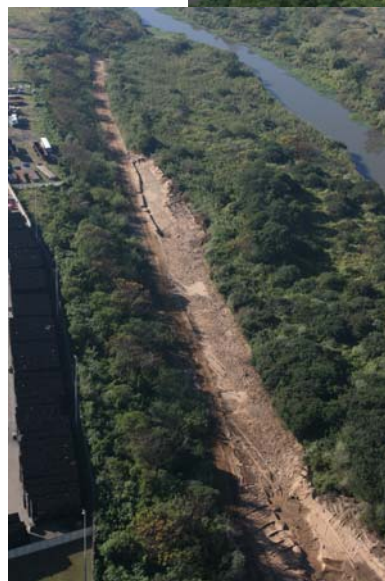
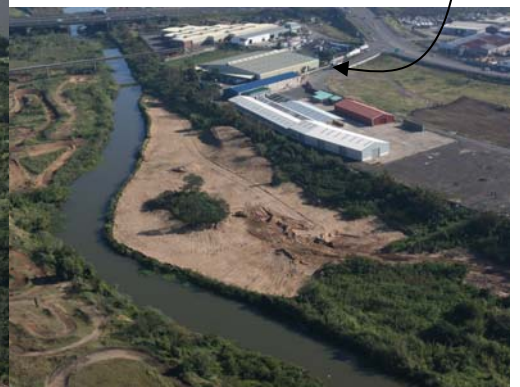
4.6 Mgeni

- The small amount of remaining riparian habitat has been surface stripped over large areas to expose the sand beneath making these areas vulnerable to erosion
- There has been major infilling of the estuary to create platforms in the past and still seems to continue
- previously mined areas left without rehabilitation

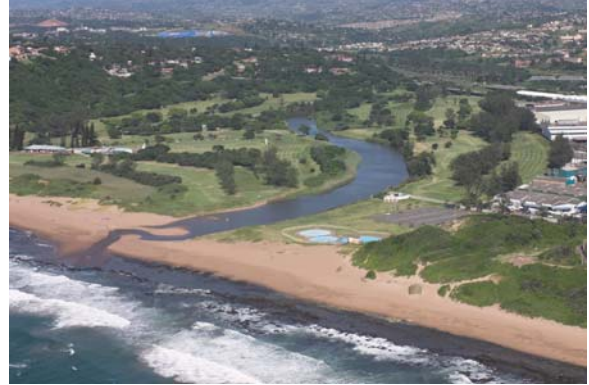
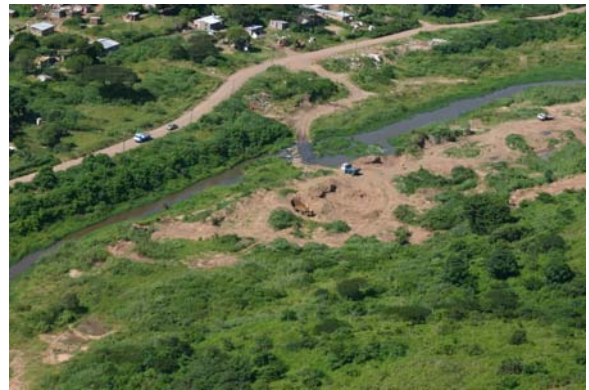
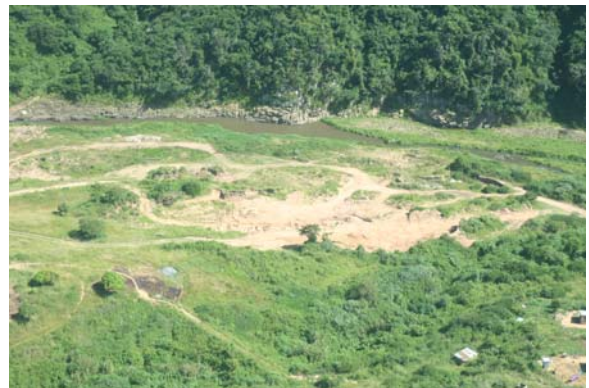
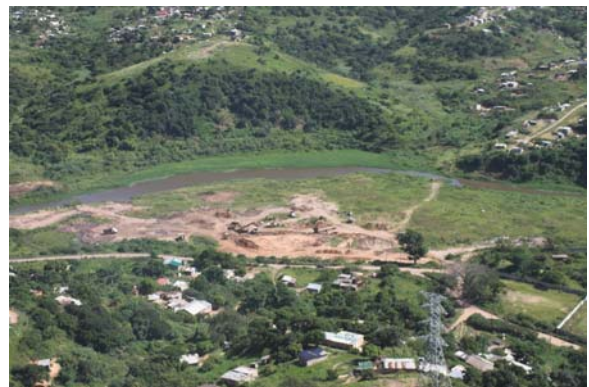
4.7 *Mbokodweni*

- Eight large operations within 15 kms of the coast
- All of these range haphazardly, clearing large areas of vegetation from the floodplain
- Several *ad-hoc* berm roads constructed across the river constrict flow and adversely impact on water quality and habitat integrity.
- High flows in this system as a result of waste water discharge probably result in scouring of exposed areas and deposition of the eroded material in the estuary.

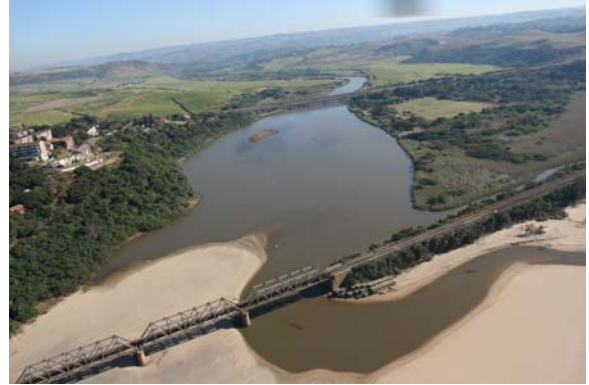
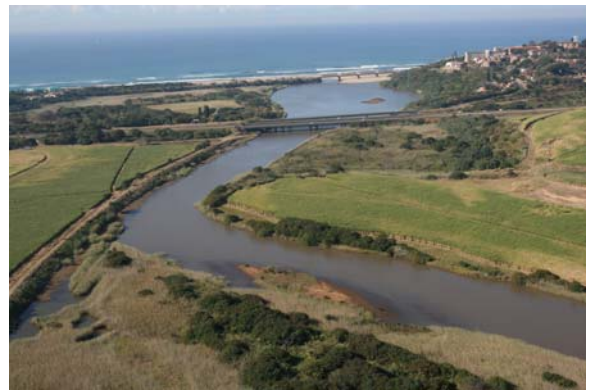
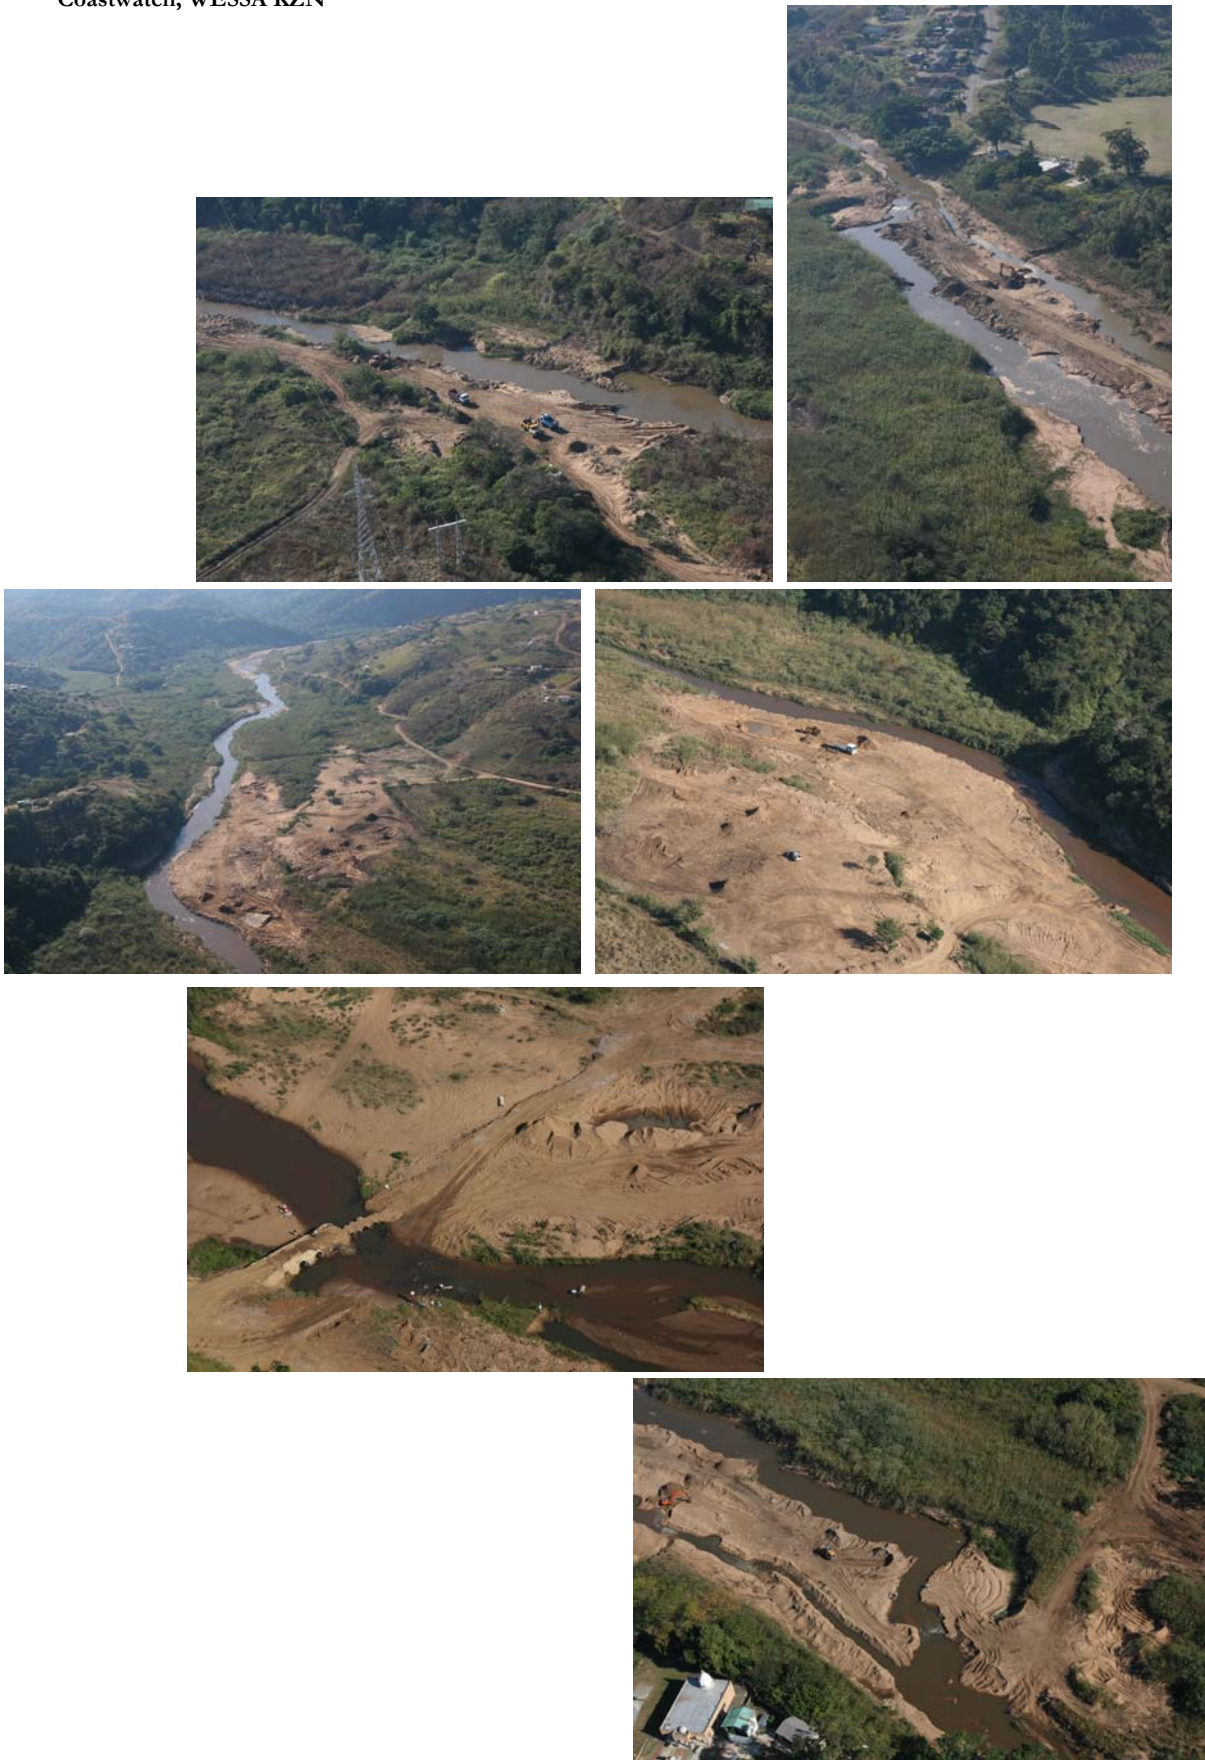
Plate 4: *Sand mining operations on the Lovu estuary clearly illustrating infilling, river diversion and destruction of riverine habitat.*

- This is a very heavily mined system on a par with the Mvoti estuary
- The pictures clearly illustrate the extent of the operations
- 3 m high berms are constructed down the centre of the river channel rendering them extremely vulnerable to erosion

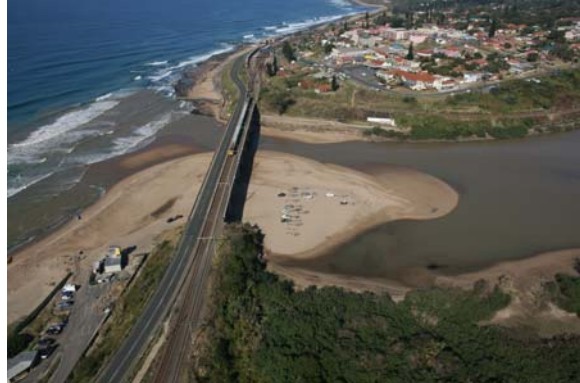
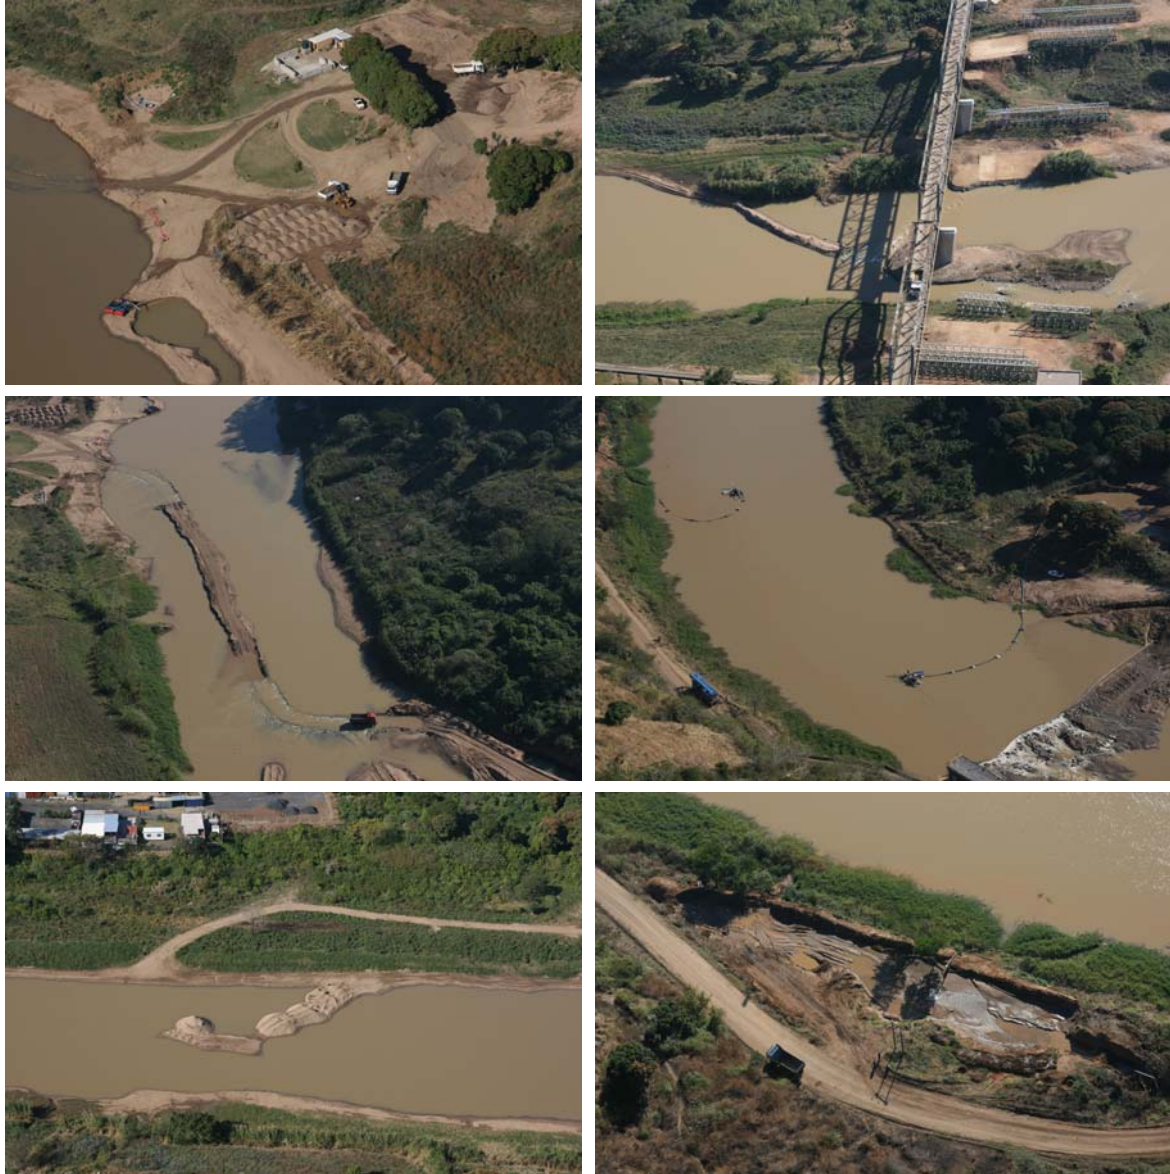
Plate 3: *Sand mining operations on the Mkomaḻi estuary. No evidence of rehabilitation as the sandmining operation moves downstream. Berms are built across almost 2/3rds of the channel and sediments continuously turned over.*

- This is another intensively exploited system and one of the only ones where the sandmining operations take place within the estuarine boundary areas (Ifafa is another of these)
- Research conducted by MER in this estuary over the last 10 years has allowed observation of the sustained exploitation and major modifications of the riparian and riverine habitats.
- The upper estuary is characterised by river diversions, unconsolidated sediments and general habitat instability.
- Invasion of the riparian areas by invasive alien species
- Increased turbidities during low flow periods as well as an increase in the sandbanks in the lower estuary and very likely linked to the activities of the sand mining operations upstream.

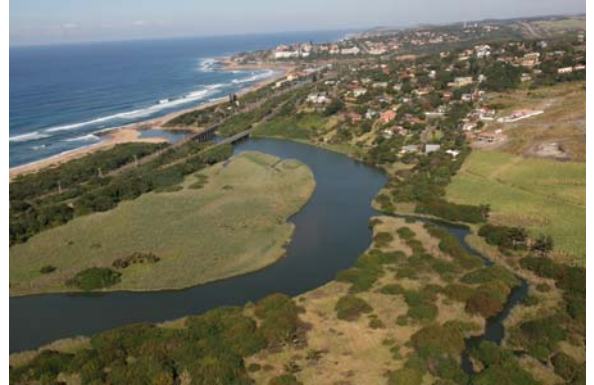
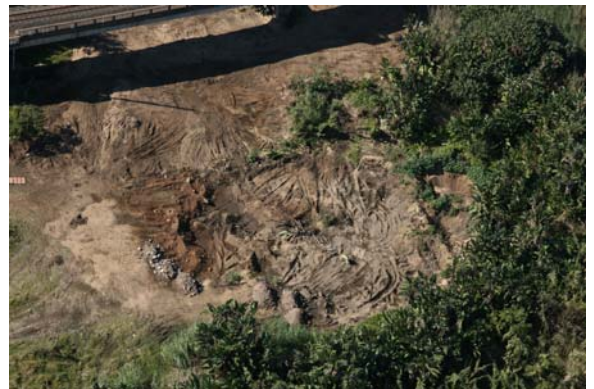
4.10 Mablongwa

- Two small operations which appear to serve the building requirements of the local community.
- Not immediately apparent if both sites were still being actively mined.
- Small catchment with very little potential to generate high sand yields.

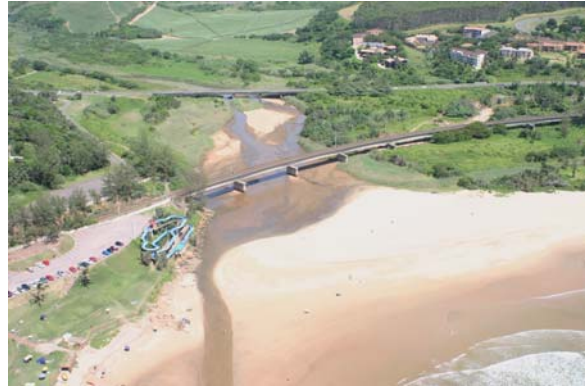
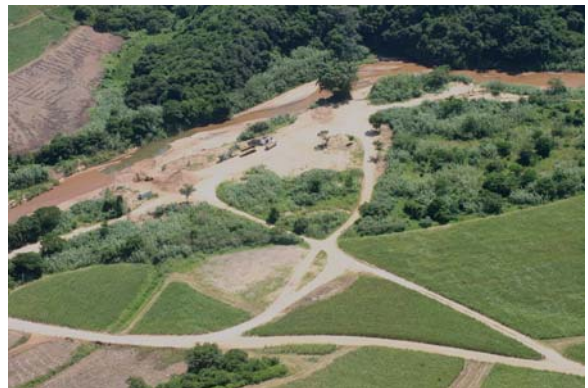
4.11 Mpambanyoni

- Only one operation approximately 5 km upstream of mouth
- Fairly large area of vegetation clearance and extensive channel modification
- No indication of rehabilitation of an adjacent previously mined site.

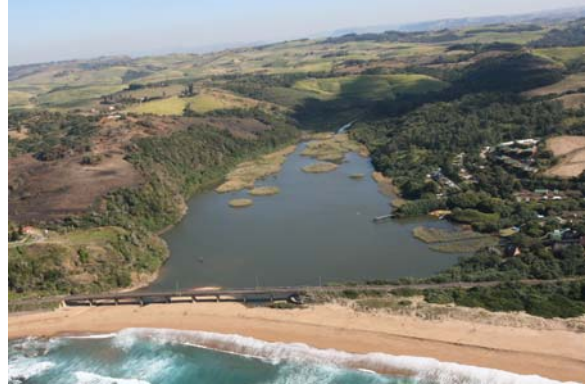
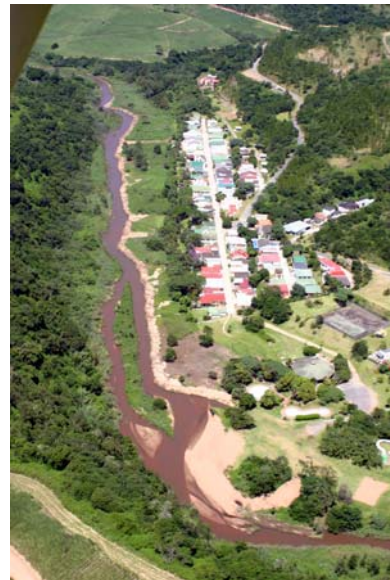
4.12 *iFafa*

- Some major mining taking place upstream of the N2 with significant channel modification, loss of riparian vegetation and stockpiling of sand
- Sand mining or channel modification in front of the Ifafa Marina complex. Piles of sand clearly visible along the river bank

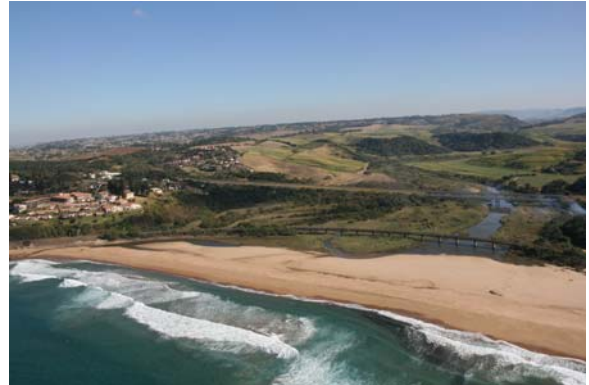
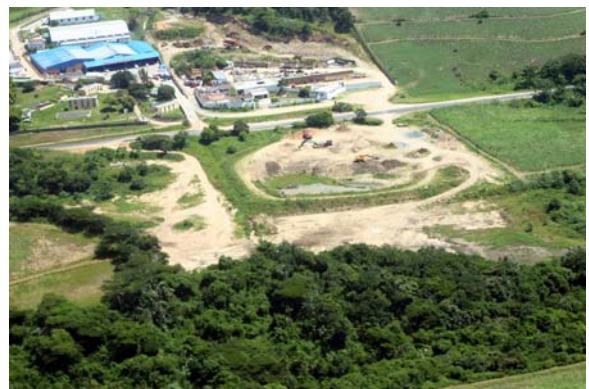
4.13 Mtwalume

- Two mines 4 – 5 km upstream of estuary mouth.
- Significant channel dredging and loss of riparian vegetation.

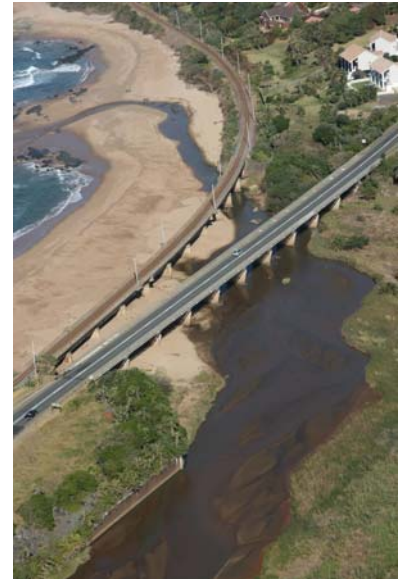
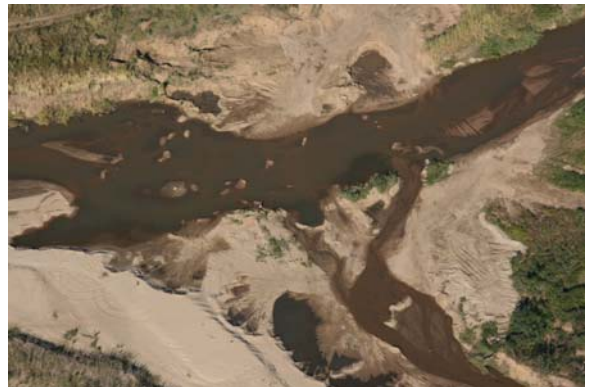
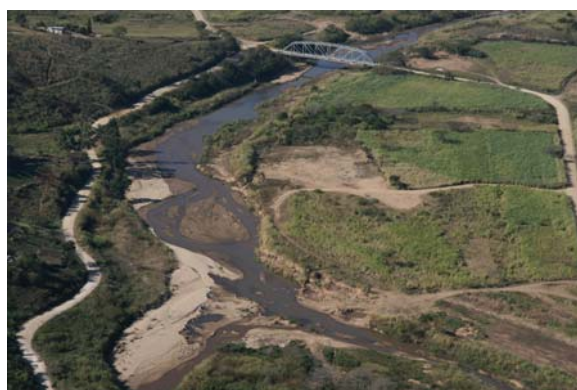
4.14 Umzumbe

- Major changes to the channel
- Loss of riparian and floodplain vegetation
- No indication of rehabilitation activity

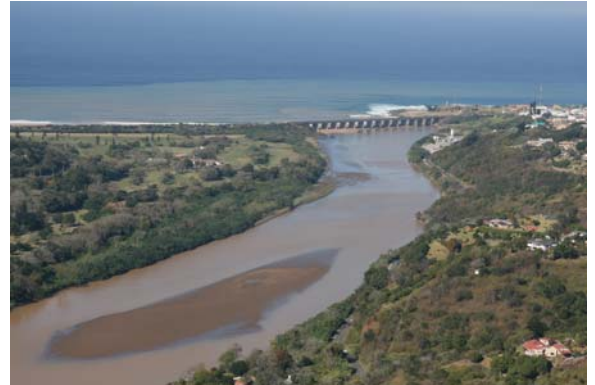
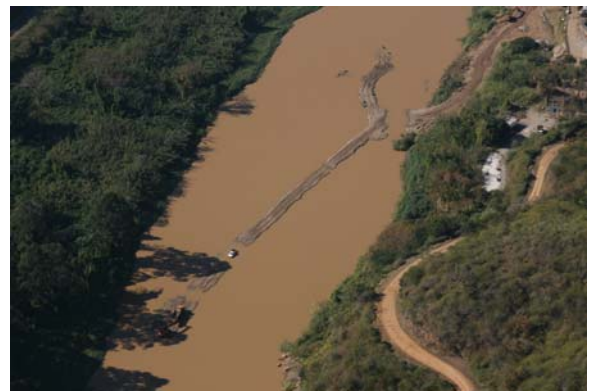
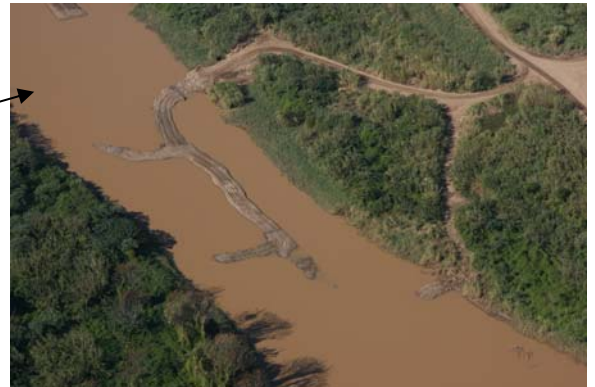
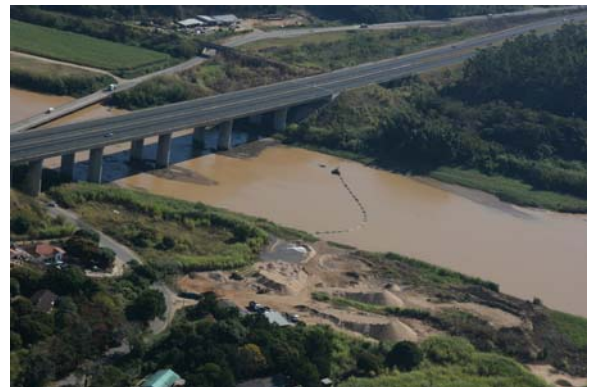
4.15 Mzimkulu

- A heavily impacted system with a large number of sand mining operations.
- The lower reaches show significant sediment accumulation in the recent past sandmining activities have arguably contributed to this situation.
- High sediment loads are particularly obvious during high flow periods.
- The same loss of riparian and floodplain habitat is apparent on this river.

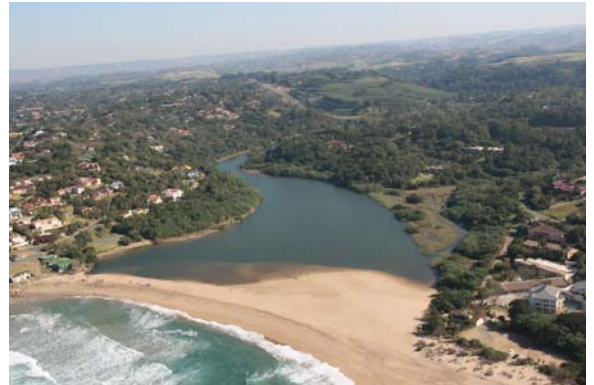
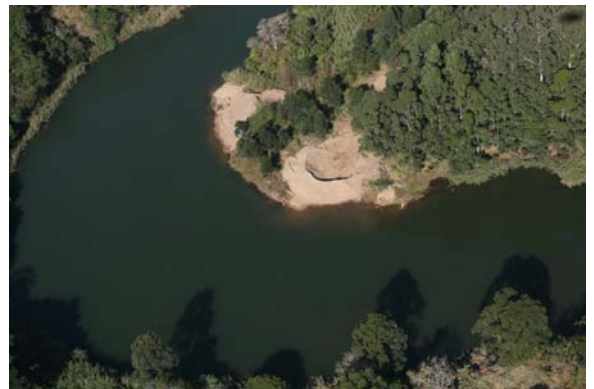
4.16 Mbizane

- Only one small operation which appeared to be operated by a local landowner.

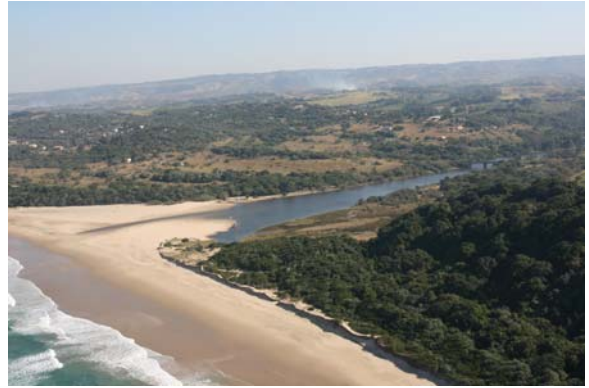
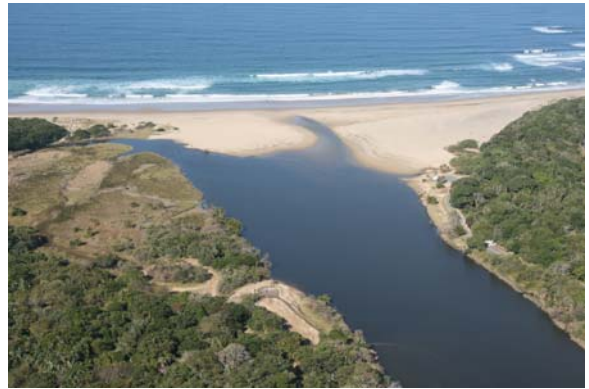
4.17 Mpenjati

- Two operations – one close to the mouth of the estuary and one above the N2 bridge.
- Long standing operations which unfortunately occur in a proclaimed nature reserve. Activities which are not compatible with the presumed goals of a nature reserve.
